**STANDARD FAILED WATERSTOP DETAIL**

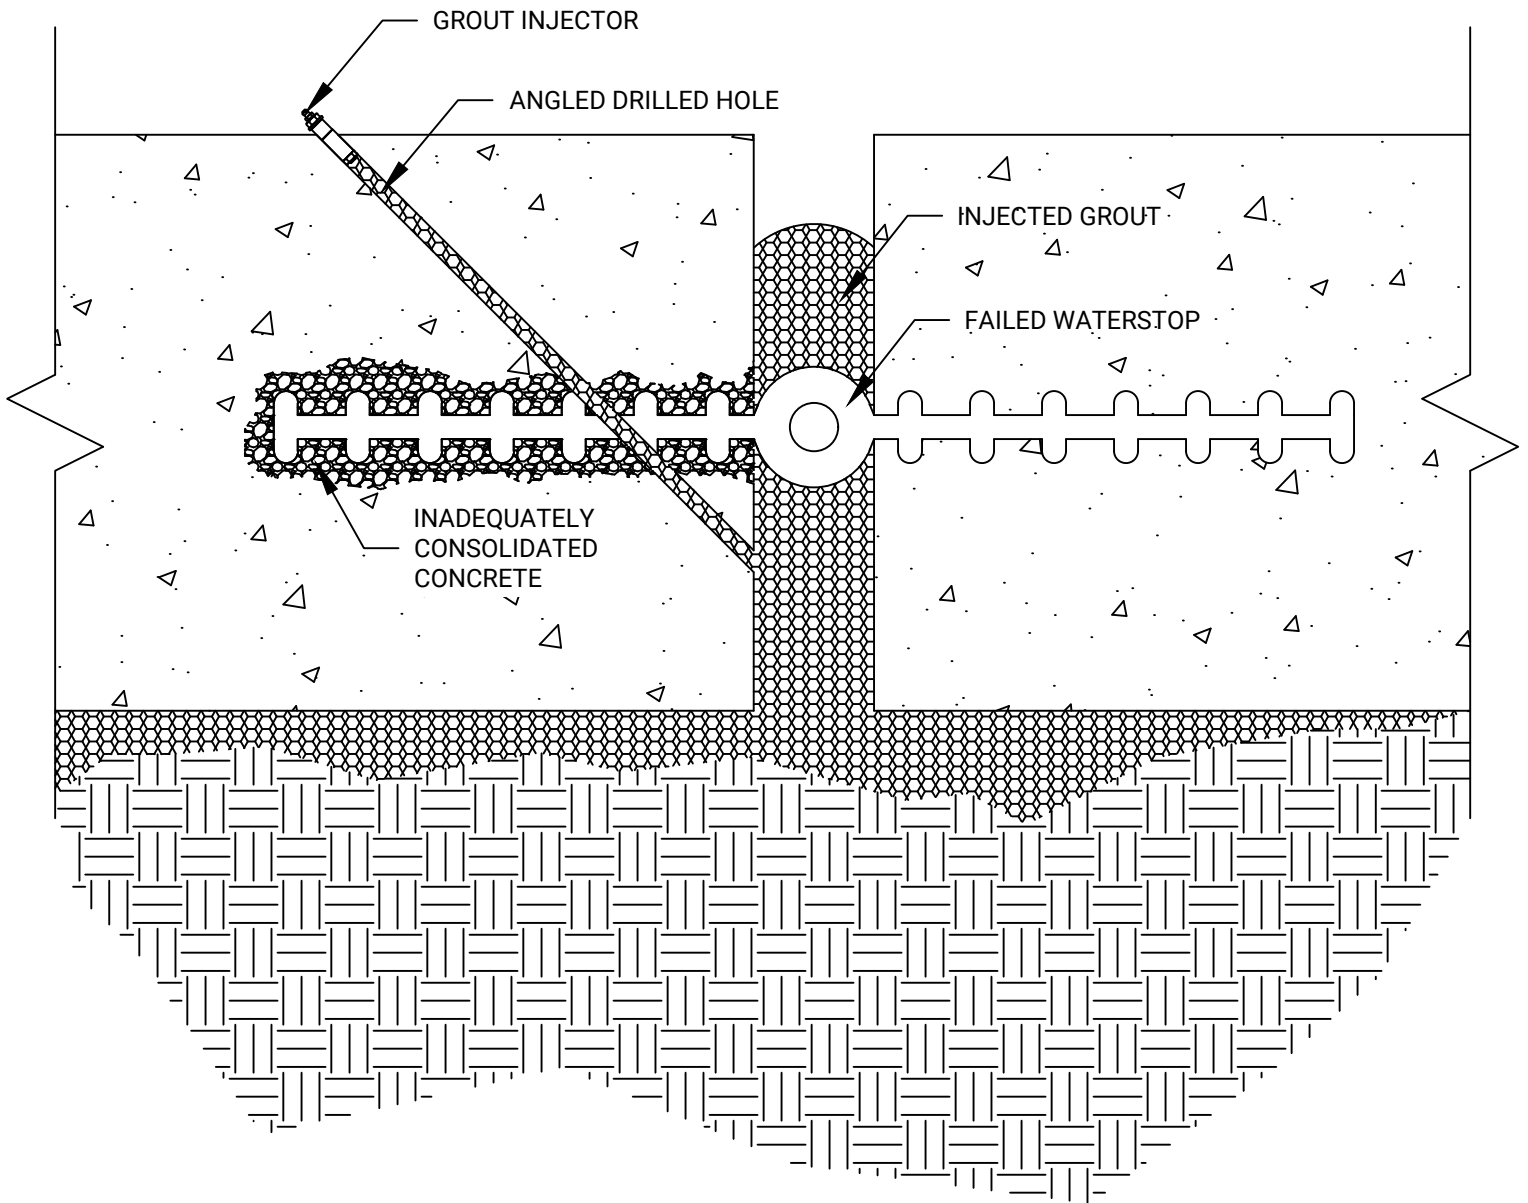
INTERNAL GROUTING WORKS BEST WHEN THE JOINT LEAK IS CAUSED BY INADEQUATELY CONSOLIDATED CONCRETE AROUND THE WATERSTOP. IT IS LESS EFFECTIVE WHEN THE LEAK IS CAUSED BY WATERSTOP TEARS OR POOR SPLICING. SUITABLE INJECTION GROUT WOULD BE:

- ADCOS PURINJECT® 1C DUO
- ADCOS PURINJECT® 1C FLEX
- ADCOS PURINJECT® 1C FLEX 55
- ADCOS PURINJECT® HYDROFOAM
- ADCOS ACRYLINJECT® AC FLEX
